Ex-Post Project Evaluation 2017: Package I-3 (Indonesia)

JAPAN INTERNATIONAL COOPERATION AGENCY

FY2017 Ex-Post Evaluation of Japanese ODA Loan

“Lower Solo River Improvement Project (Phase I)”

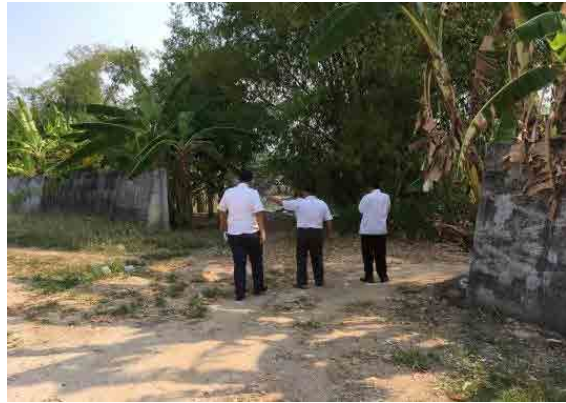
Photo 8: Levee Developed Using BBWS' Own Budget and Undeveloped Area Due to Absence of Land Acquisition

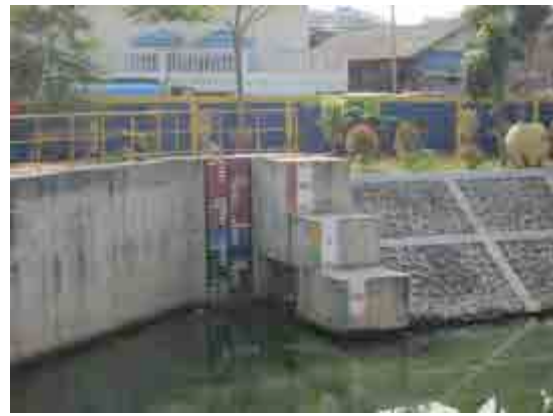
Photo 4: Pluit Pump Station
The reservoir water level is visually monitored
